Manhole Inspection Summary

Manhole # S31GG1001MH

Location Address: **110 LINKWOOD RD**

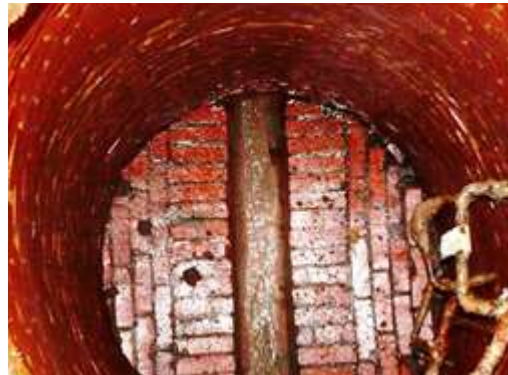
Top View

Barrel infiltration. Corroded steps.
Evidence of surcharge - Bench debris.

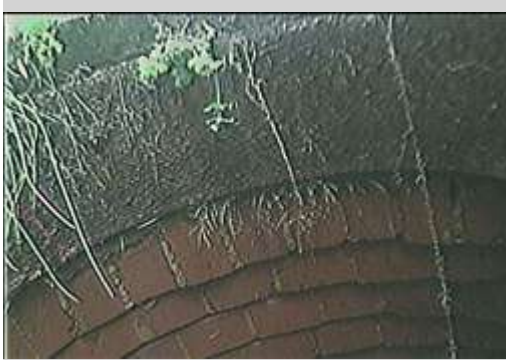
Defect

Frame leaks. Corbel root intrusion and infiltration.

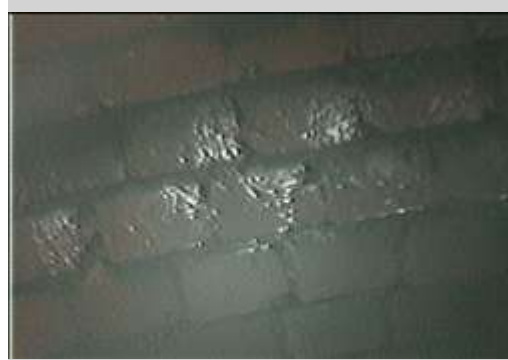
Defect

Corbel and Barrel infiltration.

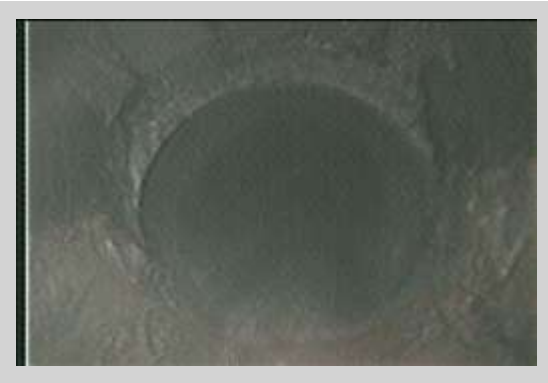
8 in. Circular Gravity Sewer Pipe Out @ 12 O'Clock

Infiltration: **Evidence** Pipe Seal Cond: **Cracked**

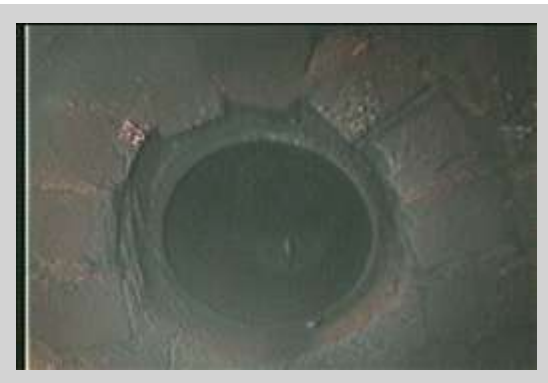
8 in. Circular Gravity Sewer Pipe In @ 6 O'Clock

Infiltration: **Evidence** Pipe Seal Cond: **Broken**

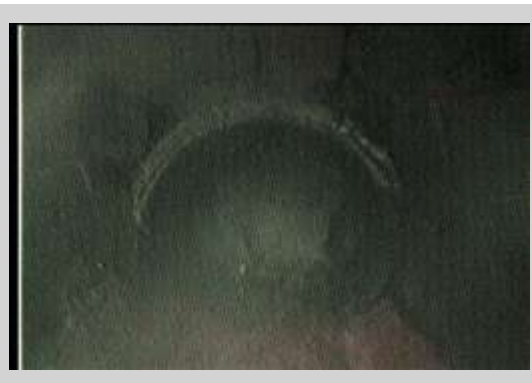
Drop In @ 6 O'Clock

Drop: **Outside** Rod and Bar

Drop Condition: **Open**
